Techno-Economic Assessment Study Rogun HPP

Phases 0 & 1 Considerations
and Assessment Status Update

Engineering and Dam Safety Panel of Experts

Engineering and Dam Safety Considerations by Panel of Experts

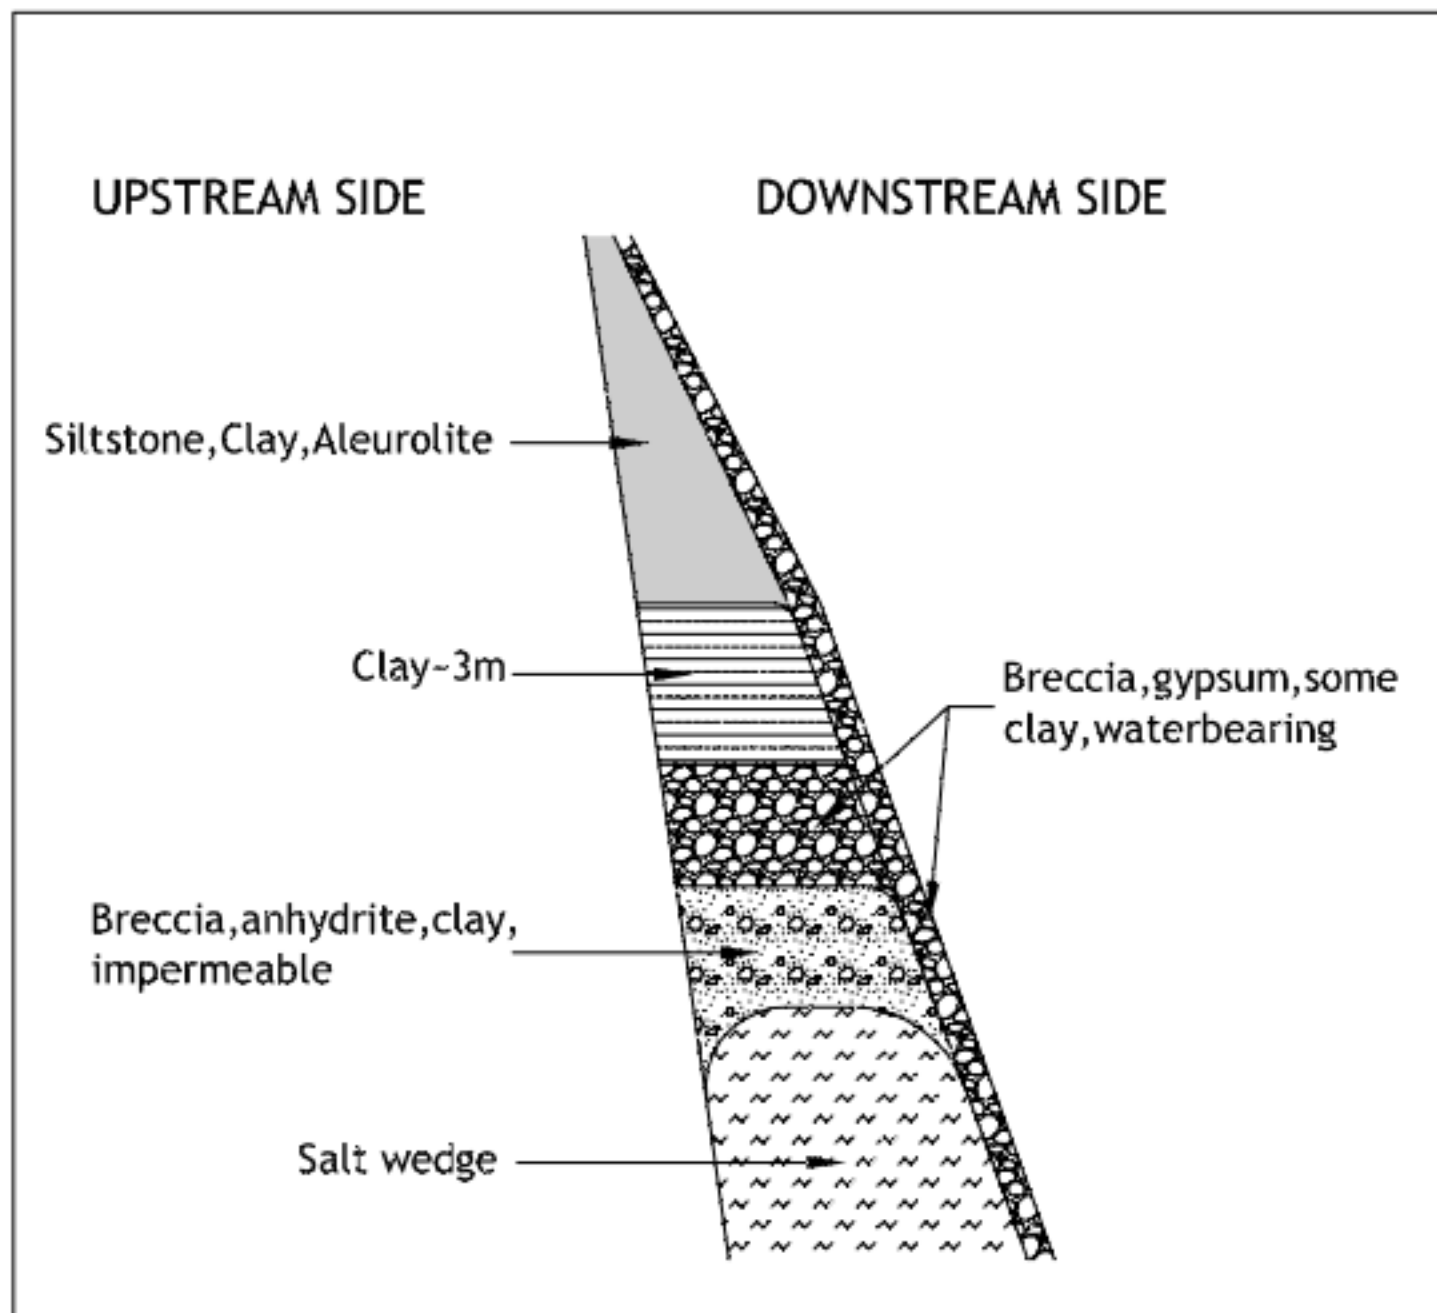
A salt wedge exists under the upstream part of the dam axis along the creeping Ionakhsh fault which, if not addressed effectively to prevent dissolution by the potential hydraulic gradient, could impact the feasibility of the project.

- The principle of applying equilibrium of hydraulic heads on both sides of the salt wedge to eliminate the hydraulic gradient, the main motor of leaching, is absolutely correct. This can theoretically address the problem.
- The grout curtain over the impermeable section of the wedge (clay cap and compact salt) forms an additional passive protection. A significant part of this curtain is already constructed.
- Both the hydraulic curtain and the grouting have to be implemented. One will cover any possible deficiency of the other. And such deficiencies may occur even if more accurate data were available

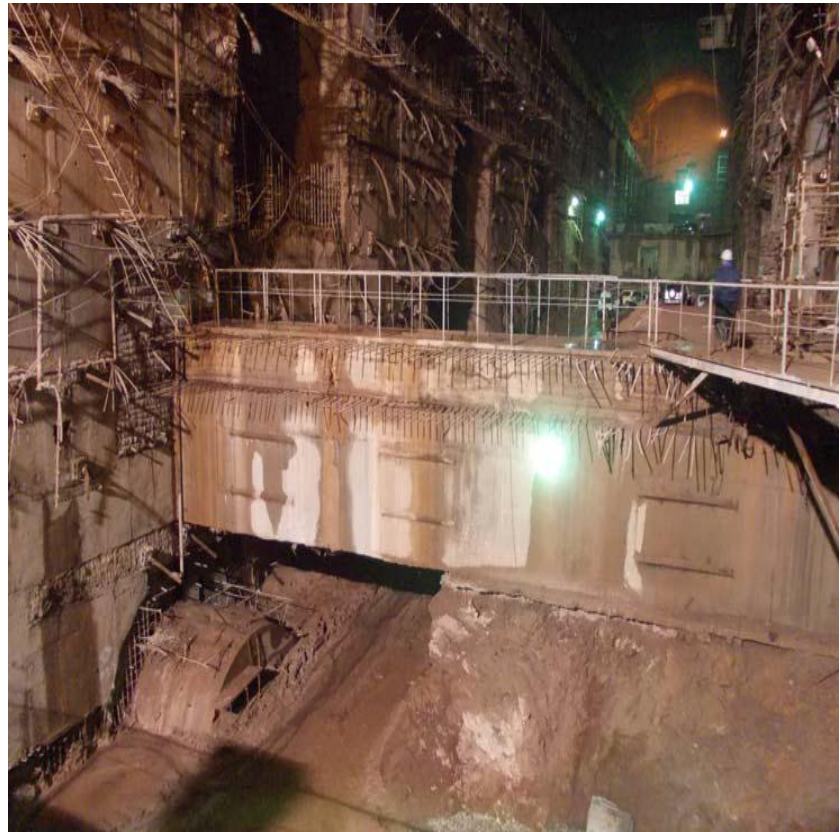
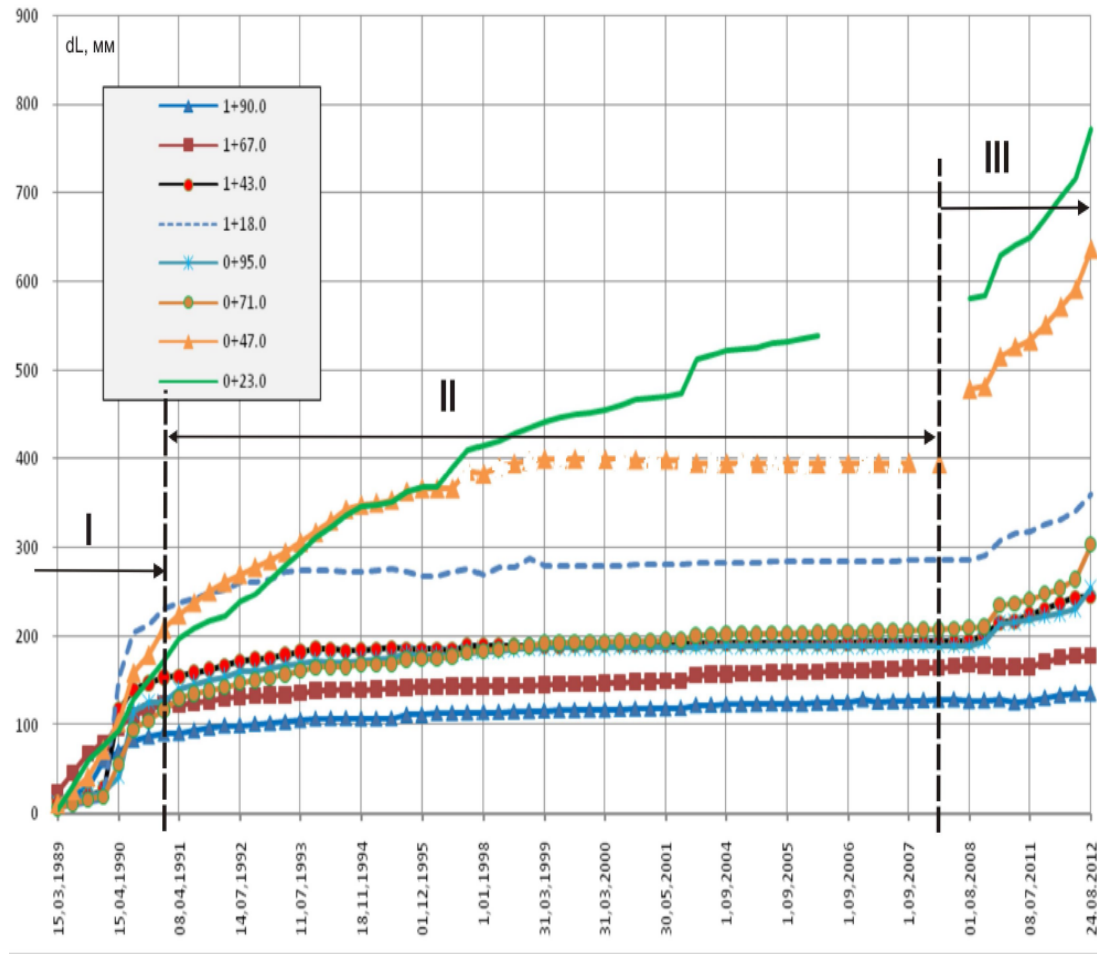
- Significant wall convergence has been recorded amounting to 600mm in the siltstone sections up to the middle of 2008 and about 750mm up to August 2102.

The convergence as presented in the graph of HPI report 2012.

Note: the scale of time is irregular and the gradient of convergence is actually lower.

The convergence should correspond to the closure of the opening of the cavern and not to the convergence of its wall.

- The PoE suggested, after the inspection in April 2013, the possibility of progressive distress of the rock mass in association with the ageing of the strengthening measures applied since the late 80s, to be the reason of the time dependent deformation and not a gradual deterioration of the petrographic quality due to softening of the siltstone. Such a state could be addressed efficiently by additional support in the sidewalls.
- The PoE concurred with undertaking numerical modelling with all new data from measurements and laboratory test results by both HPI (3D model) and the TEAS Consultant (2D model) to resolve the feasibility of implementation of Units 5 & 6 in the siltstone zone.

- a) Installation of 35m long rock anchors on both sidewalls and in both caverns, above the current excavation level, starting from the crown downwards to reduce/limit the rate of movement, and
- b) Reinforcement and stabilisation of the highly de-stressed rock mass in the “pillar area” between the two caverns. This will be achieved by installation of the Multiple Packer Sleeved Pipe (MPSP) that will reinforce the rock mass, as well as be used for consolidation grouting.

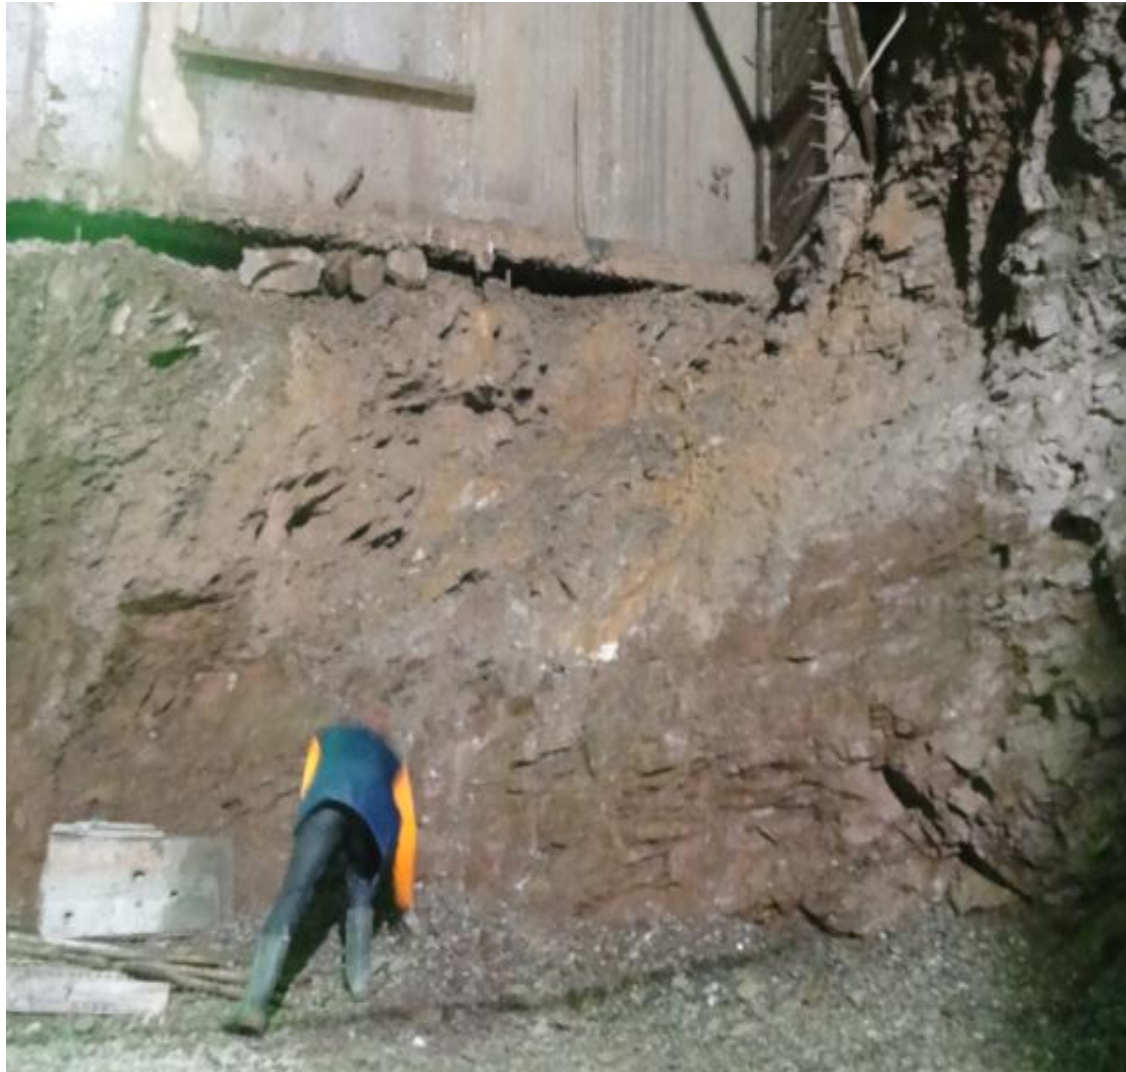
*Distressing of the siltstones after excavation,
under the concrete struts*

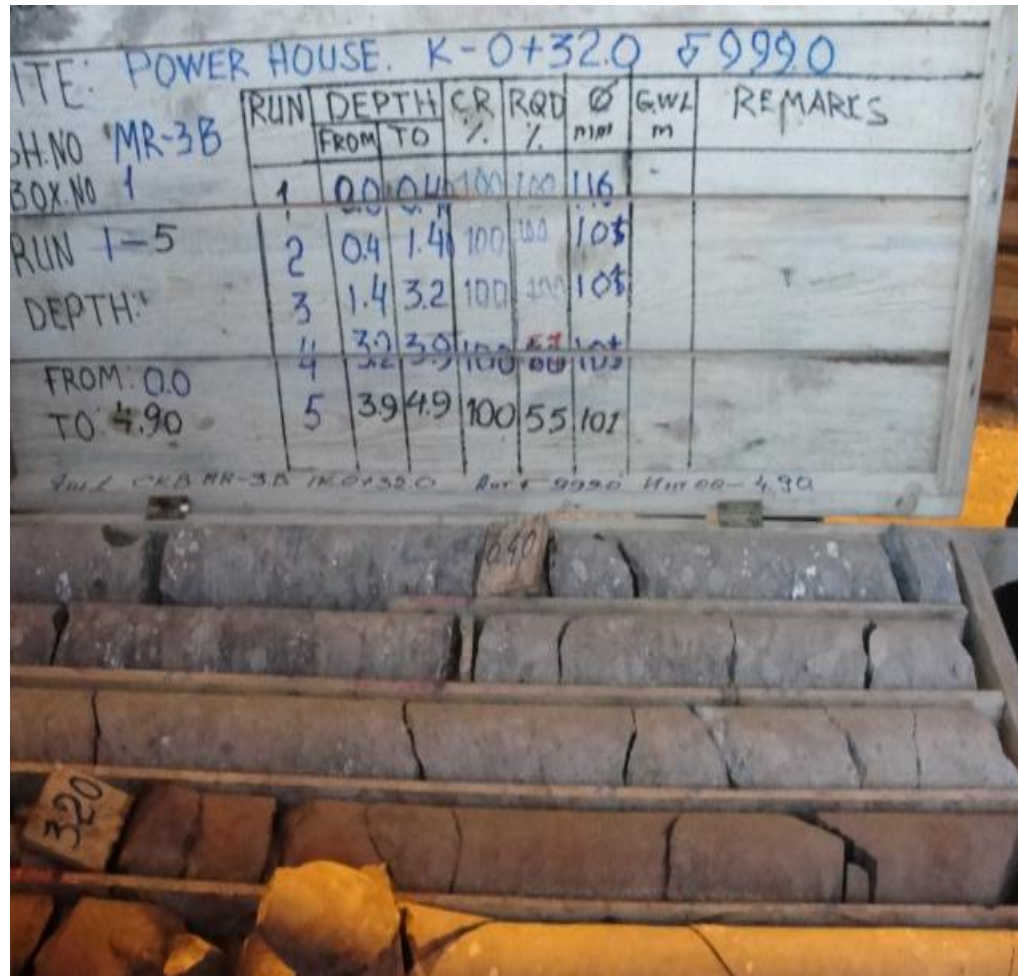
Cores of siltstone behind the concrete lining at +999.

*This area correspond in the upper part of the cavern, excavated 20 years earlier.
No change of the nature of the rock can be recognized.*

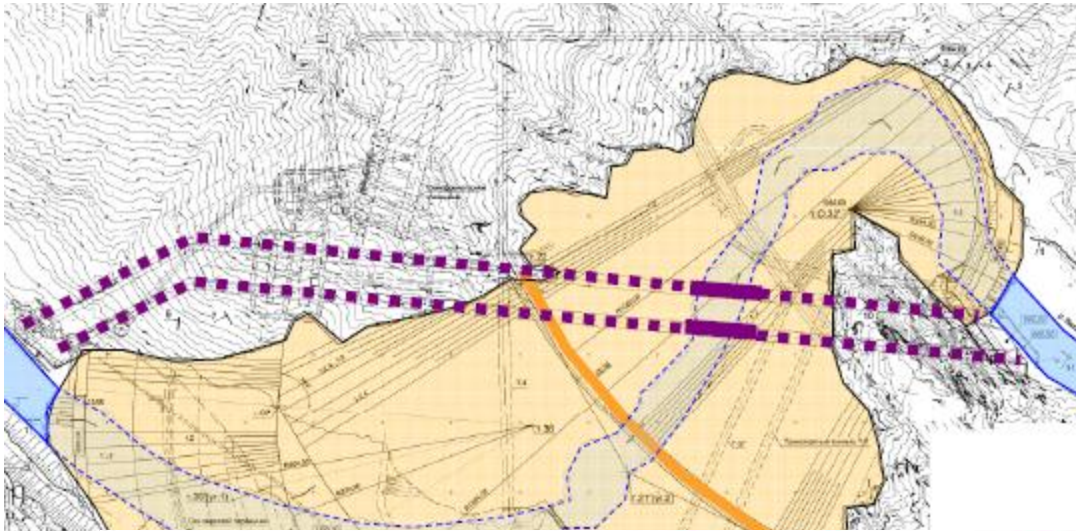
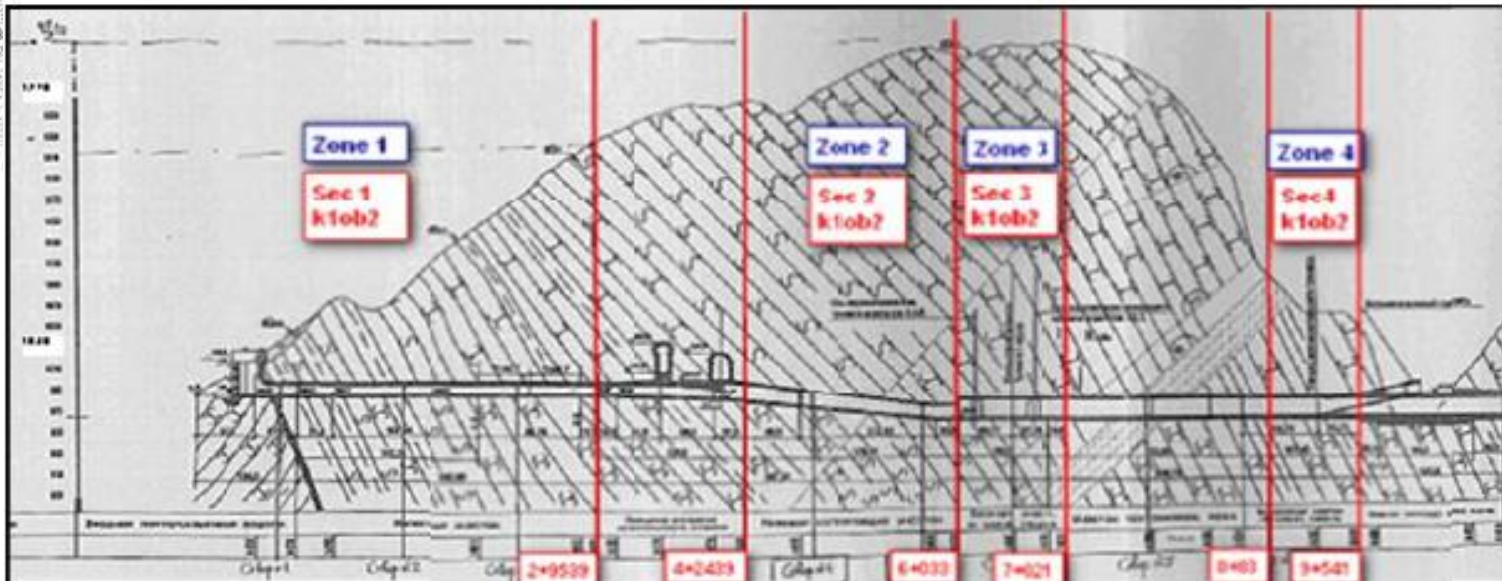
Diversion Tunnels DT1 & DT2

- DT1 & DT2 do not fulfill the technical requirements in respect to safety and serviceability required by the presently internationally recognized design criteria and standards;
- The tunnels need substantial remedial works;
- Special consideration will need to be given to the areas where the faults F70 & F35 are crossed.

- Install drainage systems through the tunnels linings or drainage galleries;
- Strengthen the structure by adding additional reinforced concrete lining and fully grouted rock dowels;
- Install high strength rock bolts to stabilize the tunnel invert in some stretches;
- Additional grouting along the stretches where high rock mass permeability was measured;
- Install special measures where tunnels cross faults F70 & F35 which will enable relative movements of the tunnel segments.
