Techno-Economic Assessment Study Rogun HPP

Phases 0 & 1 Considerations
and Assessment Status Update

Engineering and Dam Safety Panel of Experts

Engineering and Dam Safety Considerations by Panel of Experts

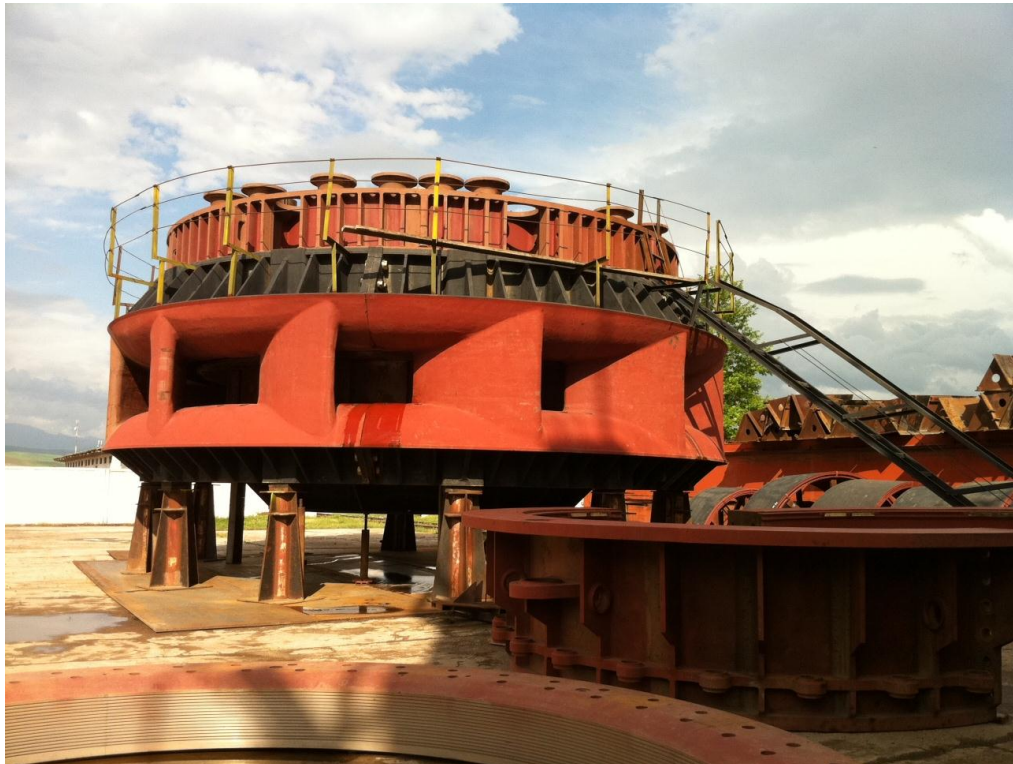
Existing M&E Equipment:

- The PoE, though John Gummer, assessed the condition of the electrical and mechanical equipment that has already been acquired and is in storage.

- The powerhouse is functionally well designed and no major changes to equipment are warranted. Attention is drawn to the measures required to avoid oil pollution of the waterways.
- The units are well designed for the era in which they were manufactured and do not require major modification. However it is recommended that the final design of the permanent runners (which have yet to be manufactured) be reviewed using modern CFD methods, with the objective of improving efficiency and performance.
- An assessment on the propensity for silt damage to the turbine hydraulic channels should be conducted.

- The staged development as foreseen in the original scheme is both safe and expedient. The only problems foreseen being loss of generation during modification of the turbines and generators. It is recommended that the option of variable speed generators for Units 6 and 5 be investigated as this has the possibility of giving considerable economic benefits as a result of continuous generation and improvements in turbine efficiency during long term generation.
