**TECHNO-ECONOMIC ASSESSMENT STUDY
FOR ROGUN HYDROELECTRIC CONSTRUCTION PROJECT**

**Geological and geotechnical
investigation of the salt dome in
the dam foundation and reservoir
(Summary)**

Phase 0 report

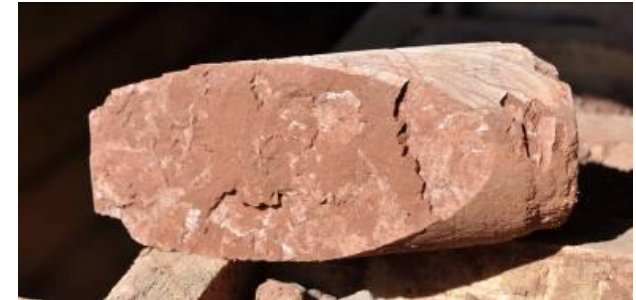
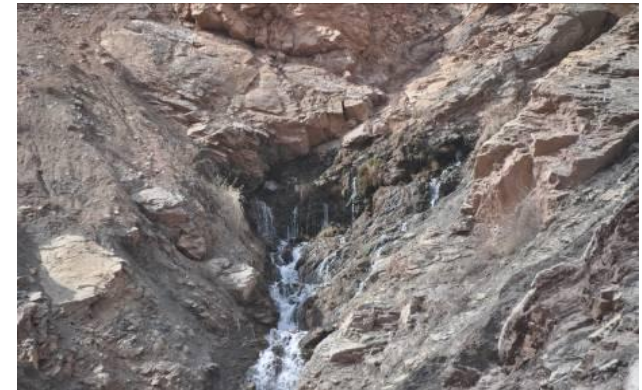
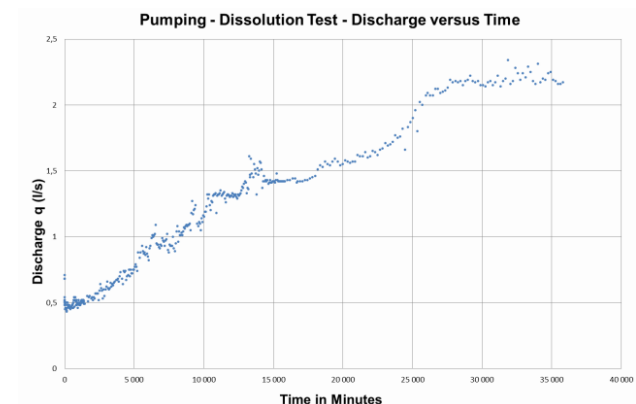
APPROACH – SITE DATA COLLECTION

- Use of data available from existing campaigns (piezometer readings...)
- Site visit with data collection (discharge measurements, chemical content analysis of springs)
- 18 boreholes equipped with observation wells and monitored
- Large scale pumping dissolution test carried out in December 2012 in one of the boreholes

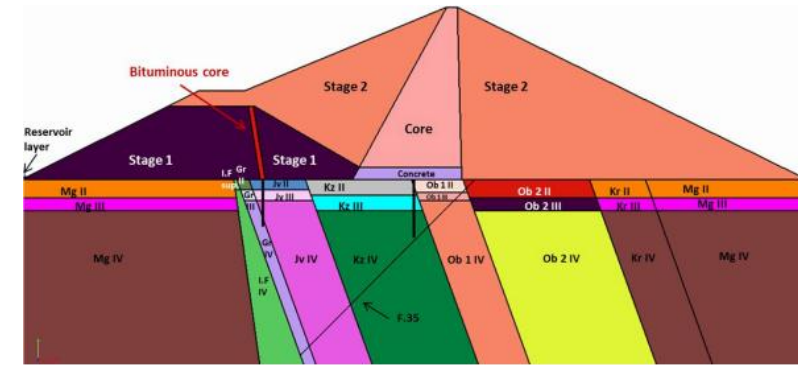
- Three interconnected sub-models have been set up by TEAS consultant
- Groundwater flow model
- Dissolution process model
- Transport model

model by TRACTEM ENGINEERING S.A. (France)

- Sub-model 1 Groundwater flow model

- Simulates the **groundwater flow around the salt wedge** for various natural conditions, different project stages, mitigation works and different levels of mitigation efficiencies,

- Sub-model 2 Leaching process model

- it models the **maximum leaching ability** inside the part of the salt wedge subject to dissolution. A salt wedge thickness subject to leaching has to be introduced, the introduced gradient at the salt wedge results from submodel1,

- Sub-model 3 Transport model

- it represents the **transport processes**: diffusion and advection/convection. The gravity convection is not modelled. **The results of the pumping test**: hydraulic conductivity and kinematic porosity are introduced. The introduced groundwater gradients are the **results of sub-model 1**. The model is **calibrated** on the observation that the **leaching is equal to the salt wedge rise**.

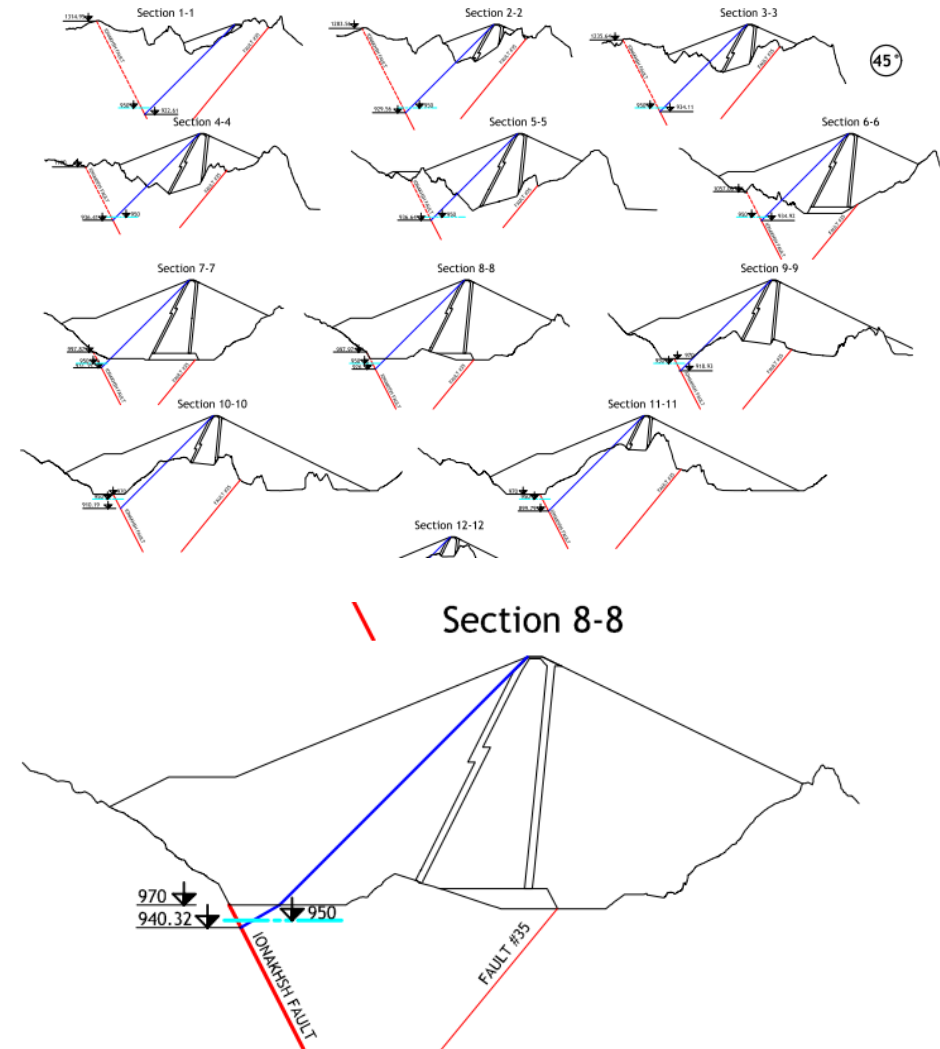
APPROACH – RISK ANALYSIS

- Risk Analysis based on various scenarios
 - Study was carried out to determine the maximum cavity size that would not damage the core and filters of the dam : Cavity generation is critical only if larger than 25 m (threshold taken at 8 m in the analysis of results).
 - Most sensitive parameters are hydraulic conductivity, groundwater gradient, wedge uplift rate, clay coating %.
 - Different mitigations measures and combinations (including existing conditions and no remedial measures scenario).
 - Sensitivity analysis on input parameters
 - Impact of delayed implementation of Stage 2 dam (Main dam construction)
